# Inspection Agreement

Prepared for: Mr Smith

12 Some Where  
Some Where, Tennessee 00000

Inspected by  
Charles Home Inspection #1677

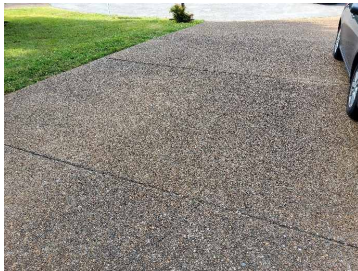
Driveway: Concrete - [Typical Cracks](#)

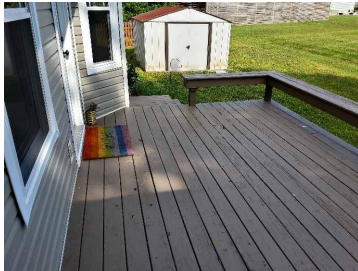
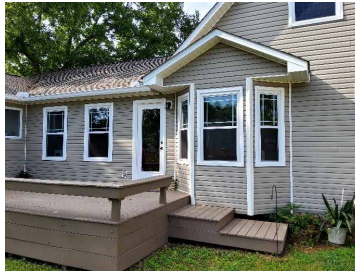
Deck: Treated wood - [Recommend adding handrailings to the deck structure.](#)

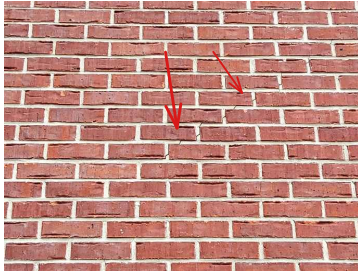
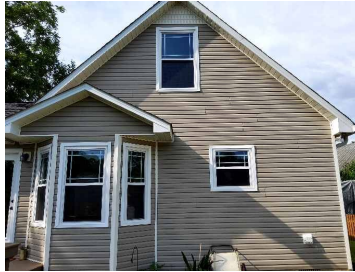
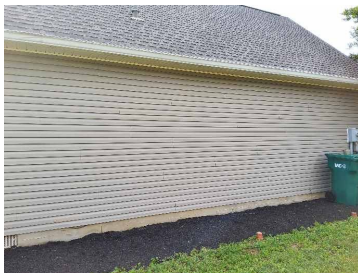
Type: Brick, Vinyl siding - [There are areas where the brick mortar has separated causing cracks. Recommend a qualified contractor evaluate and properly seal/tuck point those areas on the home.](#)

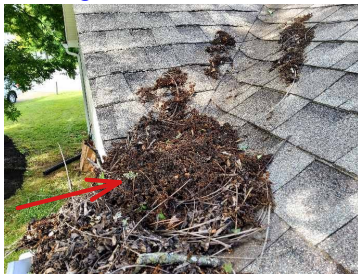
Material: Asphalt shingle - [Recommend removing the debris that is currently on the roofing area.](#)

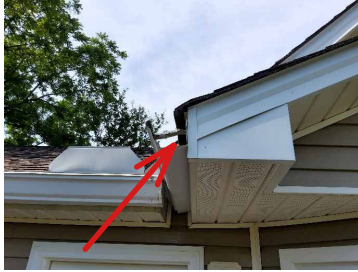
Gutters: Aluminum - The guttering along the back of the home has considerable damage. Recommend to repair or replace the current damaged guttering.

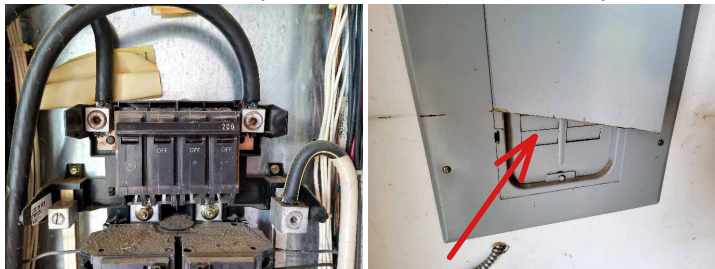
7. Maximum Capacity: 200 Amps
8. Poor Main Electrical Panel 200 Amps - [The main electrical panel cover has been altered. This poses a potential safety hazard. Recommend a licensed electrician evaluate and install a new main electrical panel cover to the breaker panel.](#)

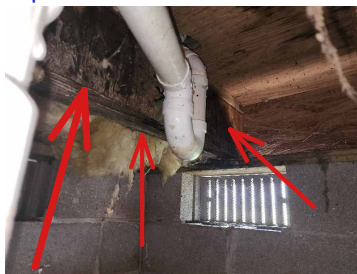
Joists/Trusses: Engineered I type - [A joists below the master bedroom has a considerable amount of water damage and microbial growth along the back side of the home.](#)

[Recommend further evaluation from a licensed contractor to determine the appropriate repairs to be made.](#)

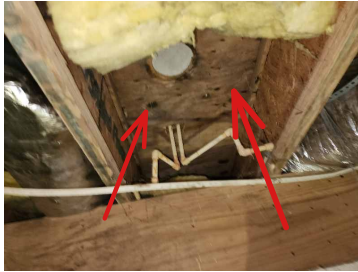
Subfloor: OSB - [The subflooring has a small amount of a microbial growth throughout the crawlspace area. Recommend a qualified technician evaluate and take the necessary steps to remediate the microbial growth from the crawlspace area.](#)

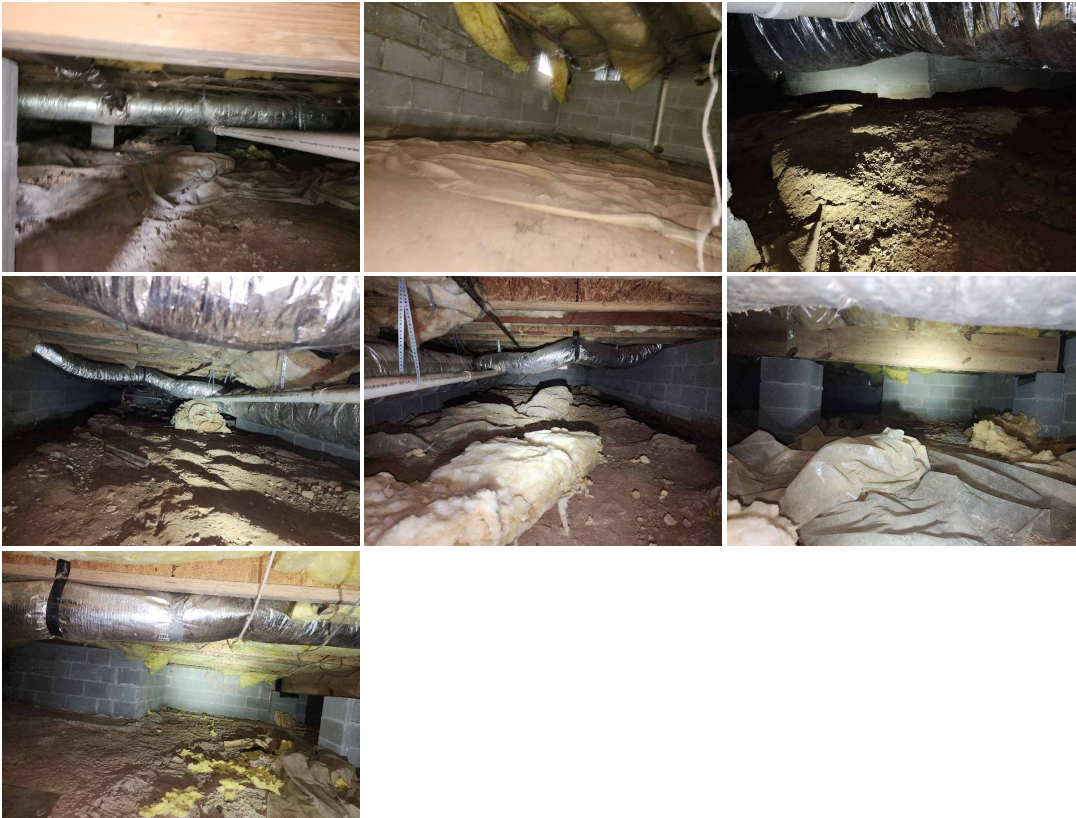
- 2. Satisfactory                      Access: Open
- 3. Satisfactory                      Moisture Penetration: No moisture present at time of inspection
- 4. Satisfactory                      Ventilation: Wall vents
- 5. Marginal                            Insulation: Fiberglass - **There are multiple areas where the insulation has come detached throughout the crawlspace area. Recommend a qualified contractor evaluate and replace the damaged insulation throughout the crawlspace area.**
- 6. Marginal                            Vapor Barrier: Partial coverage - **Recommend installing a new vapor barrier covering the entire crawlspace area.**
- 7. Not Applicable                      Sump Pump:

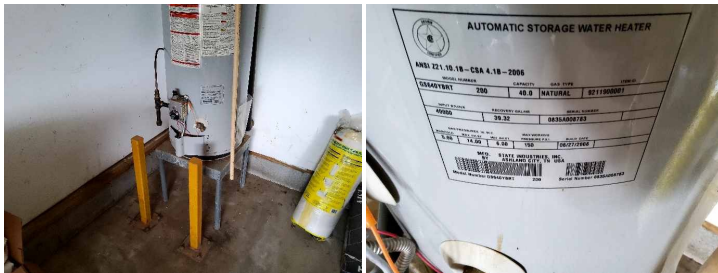
- 8. Marginal                           Water Heater Operation: Functional at time of inspection - [Water heater is nearing the end of it's design life](#)
- 9. Manufacturer: State

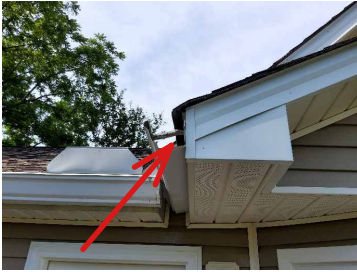
1. Gutters: Aluminum - The guttering along the back of the home has considerable damage. Recommend to repair or replace the current damaged guttering.

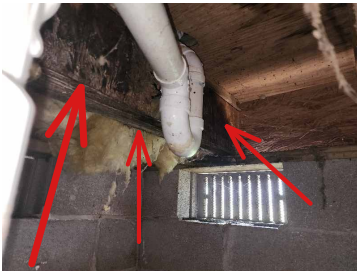
2. Joists/Trusses: Engineered I type - A joists below the master bedroom has a considerable amount of water damage and microbial growth along the back side of the home. Recommend further evaluation from a licensed contractor to determine the appropriate repairs to be made.

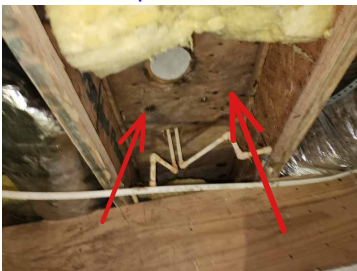
3. Subfloor: OSB - The subflooring has a small amount of a microbial growth throughout the crawlspace area. Recommend a qualified technician evaluate and take the necessary steps to remediate the microbial growth from the crawlspace area.

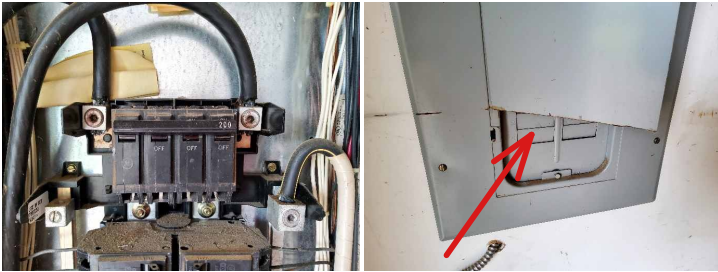
1. Garage Electric Panel Main Electrical Panel 200 Amps - The main electrical panel cover has been altered. This poses a potential safety hazard. Recommend a licensed electrician evaluate and install a new main electrical panel cover to the breaker panel.
