# Inspection Agreement

Prepared for: Mr Smith

12 Some Where  
Some Where, Tennessee 00000

Inspected by  
Charles Home Inspection #1677

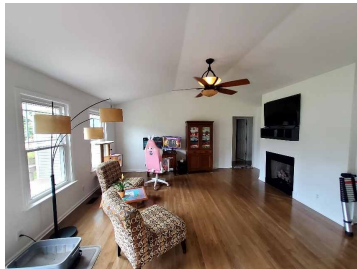
Floor: Wood, Vinyl/Laminate  
Doors: Wood  
Windows: Vinyl casement - [The right side window will not stay in the up position when operated. Recommend a qualified contractor evaluate and repair or replace the current kitchen window.](#)
